Smoke and Dye Testing Summary

High Level Sewershed

Test ID	Test Type	Date Inspected	Company / Super.	Blower MH	Ground Condition	Notification Made?	Total Length
S1028-121	Smoke	10/20/2008	ADS/TM	S0700_020MH	Dry	Yes	1,105.18

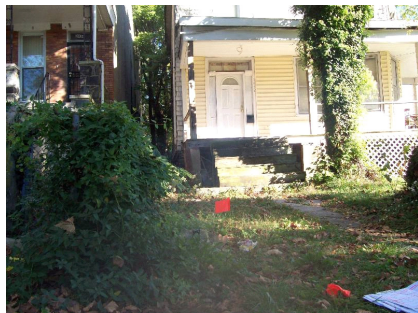
Picture \S1028-121-OB01-P01.jpg

Comments Smoke from cleanout in front yard. 3432 Piedmont Ave.

Comments Front of house, 3432 Piedmont Ave.

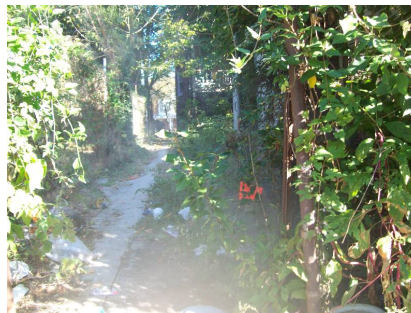
Picture \S1028-121-OB02-P01.jpg

Comments Smoke from cleanout in back yard. 3437 Piedmont Ave.

Comments Back of house, 3437 Piedmont Ave.

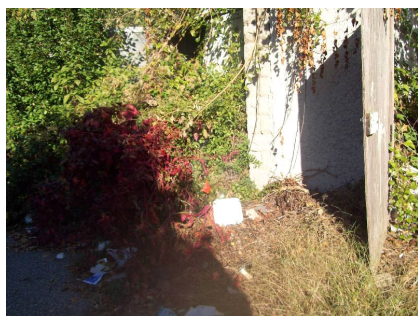
Picture \S1028-121-OB03-P01.jpg

Comments Smoke from cleanout in back yard. 3435 Piedmont Ave.

Comments Back of house, 3435 Piedmont Ave.

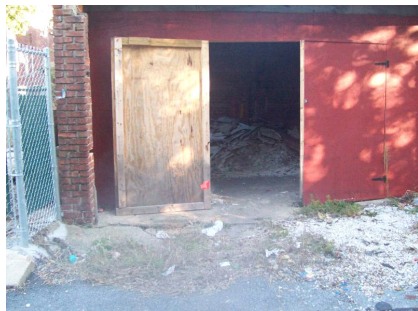
Picture \S1028-121-OB05-P01.jpg

Comments Smoke from cleanout in back yard. 3417 Piedmont Ave.

Comments Back yard, 3417 Piedmont Ave.

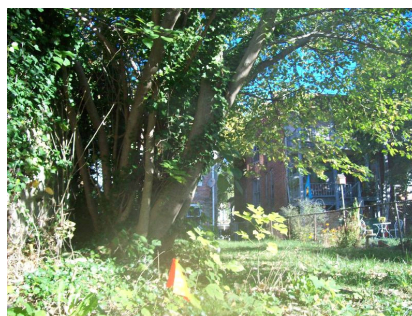
Picture \S1028-121-OB04-P01.jpg

Comments Smoke from cleanout in back yard. 3425 Piedmont Ave.

Comments Back of house, 3425 Piedmont Ave.

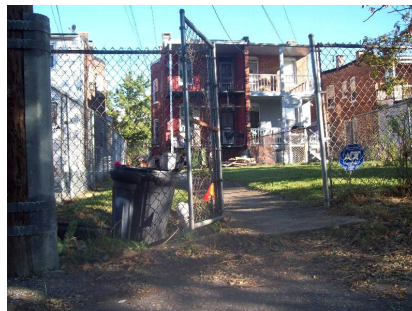
Picture \S1028-121-OB06-P01.jpg

Comments Smoke from cleanout in back yard. 3407 Piedmont Ave.

Comments Back of house, 3407 Piedmont Ave.
